**ASBESTOS IDENTIFICATION SURVEY  
3005 PACKARD ROAD  
ANN ARBOR, MICHIGAN**

**DOWNRIVER COMMUNITY CONFERENCE  
BROWNFIELD CONSORTIUM  
15100 NORTHLINE ROAD  
SOUTHGATE, MICHIGAN**

**AKT PEERLESS PROJECT NO. 6588F-3-194  
JULY 2, 2010**

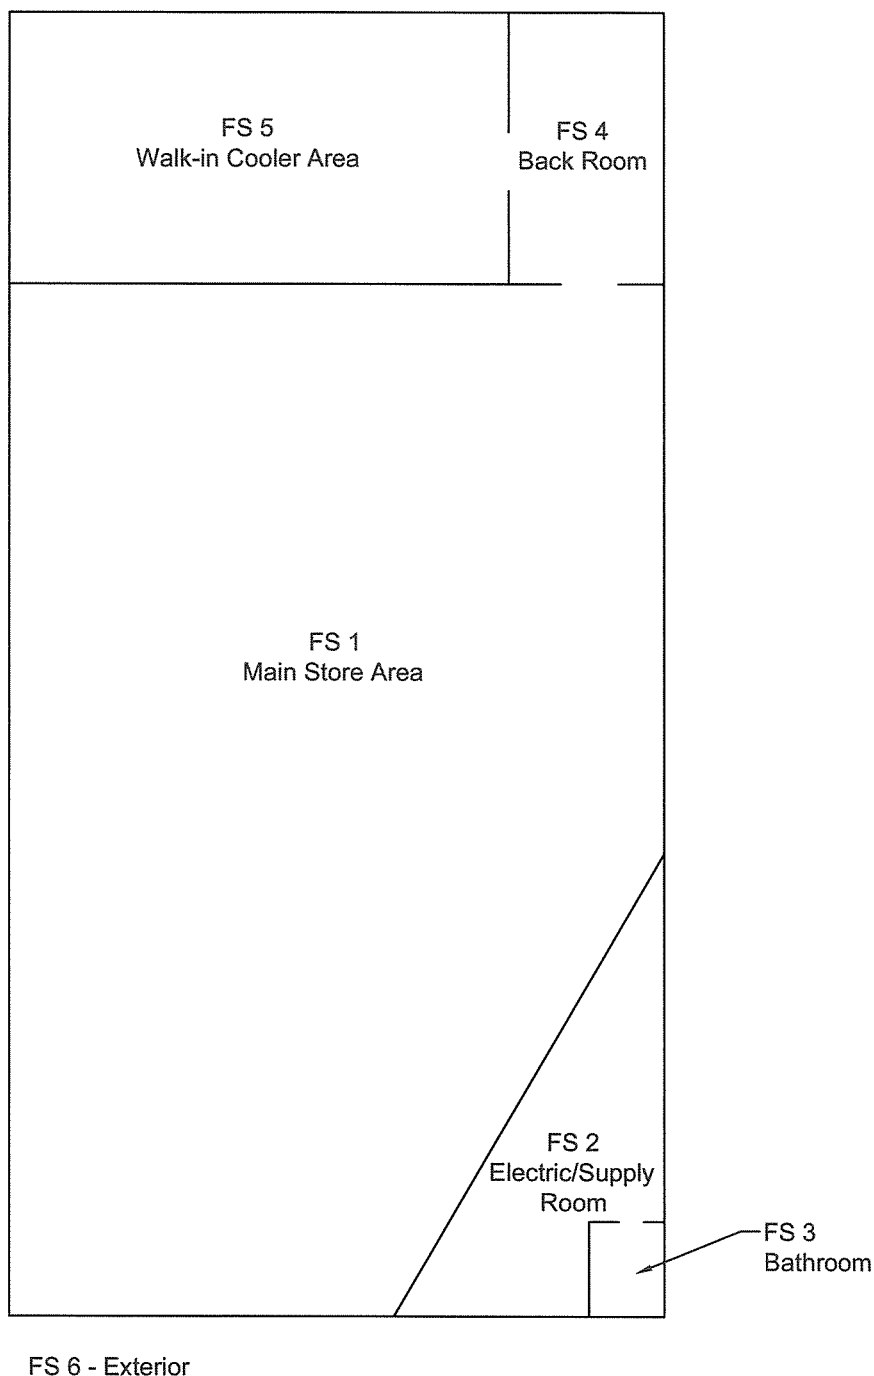
**FIGURE**

The functional spaces are depicted on the floor plan layout included in Figures 1. Functional spaces are also listed in Appendix A.

3005 Packard Road			
8 Homogeneous Areas & 6 Functional Spaces			
Description of ACM	ACM Location and Functional Space (Refer to Figure 1)	HA No.	Approximate Quantity
Roofing Material	FS-6 Exterior	8	Not Estimated

1. HA-8 Roofing Material is considered non-friable. This material was assumed ACM. Additional testing could be performed to determine if the material is ACM. Non-friable roofing materials do not require removal when subject to standard demolition procedures. .
